YOUR Inspection Report

62 Mordecai Lincoln Road - The Mordecai Home
Scituate, MA 02066

BEACON
STREET
HOME
INSPECTION

RE: Report No. 2043
62 Mordecai Lincoln Road - The Mordecai Home
Scituate, MA
02066

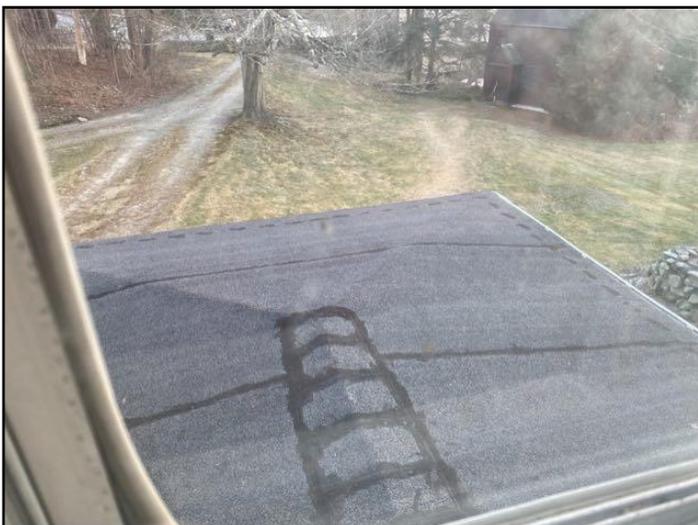
The rolled asphalt roof covering protecting both the front vestibule and left side porch are nearing full depreciation. These materials have nearly reached the end of their useful life. Recommend you consult with a qualified roofer to evaluate further and collect a price estimate for replacement of these coverings.

Roll roofing above vestibule

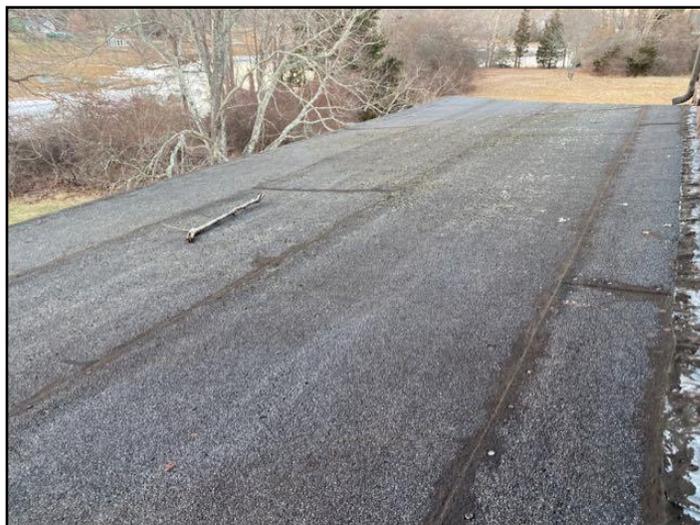
Roll roofing above left porch

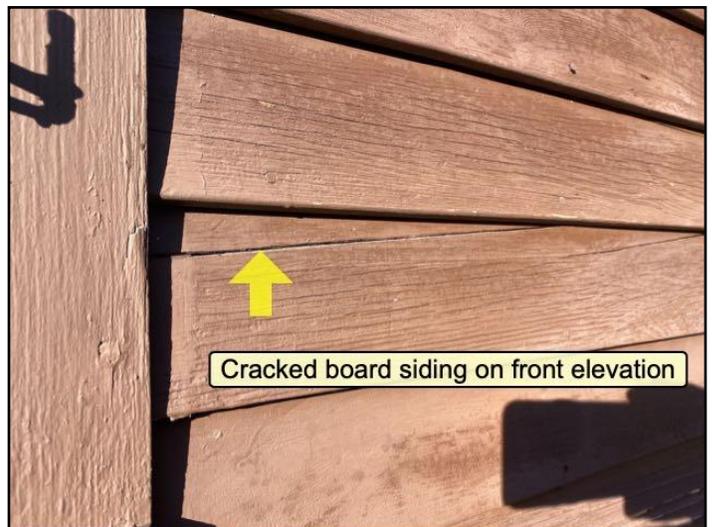
The wood shingle siding on the building is well into its useful life. Significant areas of cracked, damaged, buckling and/or lifting shingles are present, particularly along the right gable end and the rear elevation. While not an item of immediate concern this type of wear is generally considered to be the visual signs of depreciation. At some point in the future, these exterior elevations, starting with the right gable end, will need to be re-sided. This eventual improvement will represent a considerable expense. Recommend you gain a ballpark understanding of what that cost may be and plan accordingly.

Front elevation

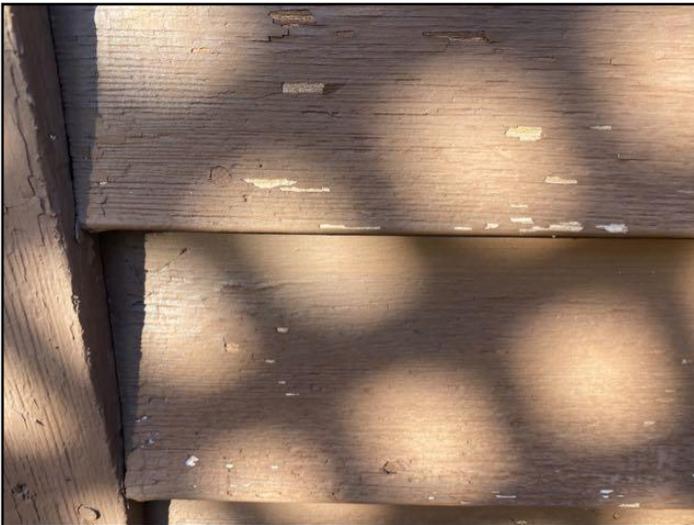
Much of the exterior paint films are thinning. Areas of chipping and flaking paint are readily visible on nearly every elevation of the exterior. While not an immediate concern the exterior will need to be painted by a qualified contractor in the future.

Detail of thinning paint films

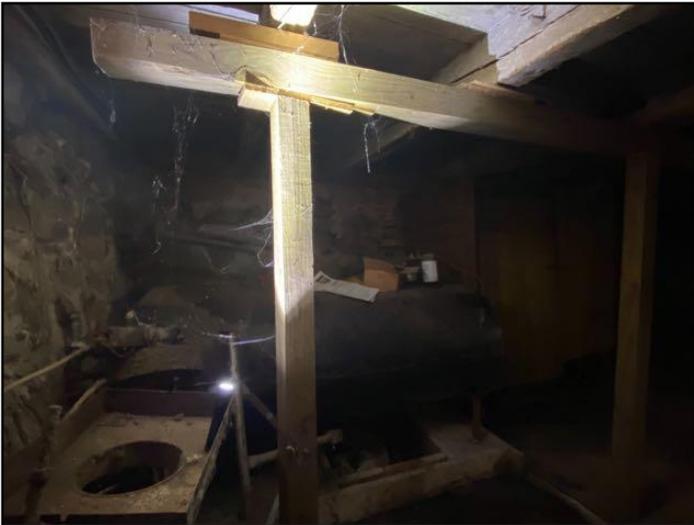
A secondary wooden post-and-beam support has been installed, running front-to-back, in the cellar hole. This installation does not reflect proper practices. The posts are not properly secured to the beam, nor are they secured properly to the floor. In fact, the front post is loose to the touch. Recommend you consult with a qualified contractor to have this installation improved.

Implication(s): Weakened structure | Chance of structural movement

Post and beam not secure

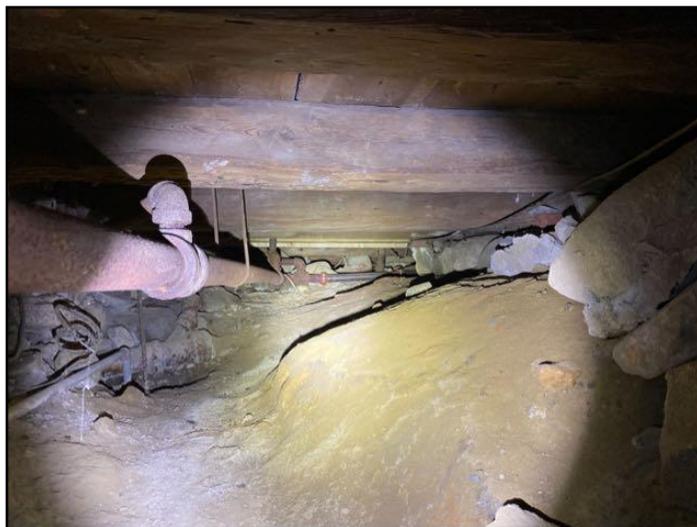
There are numerous crawlspace cavities connected to the left side cellar hole under the building: the rear, left corner, the front right and rear, right and underneath the rear ell addition. All of these crawlspaces contain exposed earth floors. No vapor barriers were noted. Structures are damaged, over time, by water in two main ways: poor exterior drainage systems and ground vapor from beneath them. This building suffers from both. Managing surrounding drainage and ground vapor are critically important factors for the long term well being of any structure. Moisture readings were taken from several framing members throughout the basement and readings were slightly elevated, (18+%). It is almost certain that lower, inaccessible areas of the crawlspaces would contain higher readings. Once moisture content exceeds 20% an environment is conducive to mold, mildew and/or decay. Improvements are strongly recommended. Along with comprehensive improvements in the building's exterior drainage system, a vapor barrier should be installed throughout all crawlspace areas under the building providing 100% coverage. Discuss with a qualified contractor.

Implication(s): Chance of condensation damage to finishes and/or structure

No vapor barrier

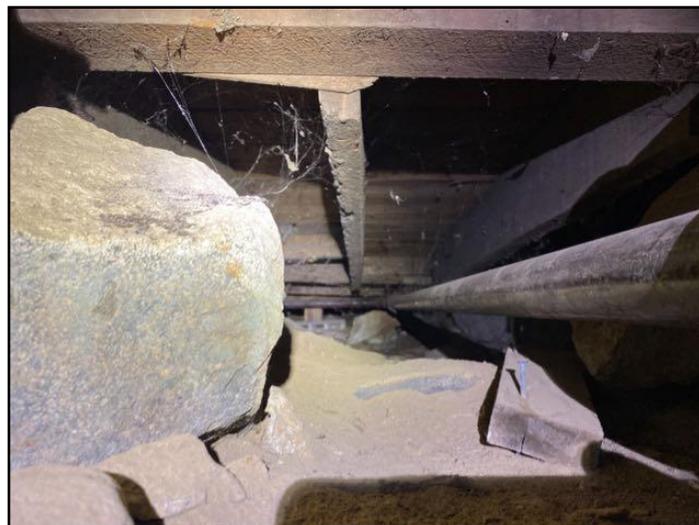
No vapor barrier

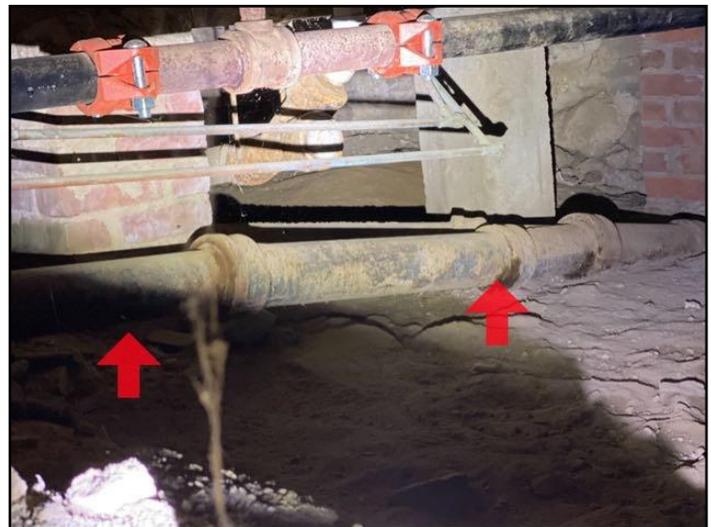
While difficult to see, there is a run of older cast iron drain line along the left side and rear crawl space. Cast iron typically has an expected life span of 50-60 years and oftentimes will rust from the inside-out. While not directly accessible, rusting was noted on several section of this drain piping. Recommend you have it evaluated by a plumber. Upgrading the drain line materials is strongly recommended.

Implication(s): Sewage entering the building

Aging cast iron drain lines

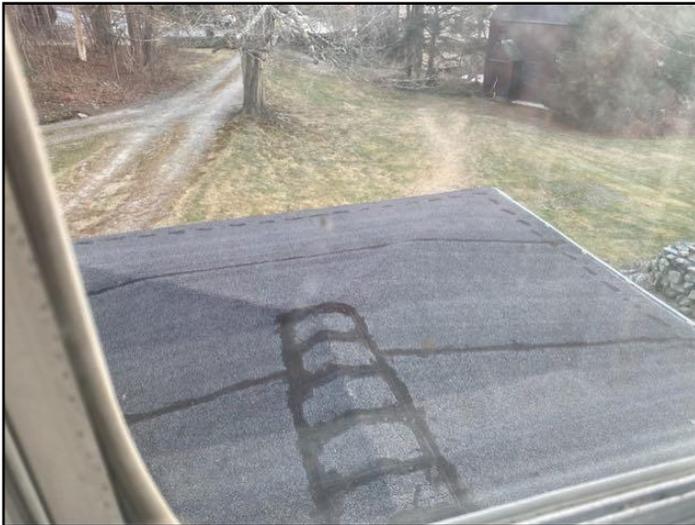
Roll roofing above vestibule

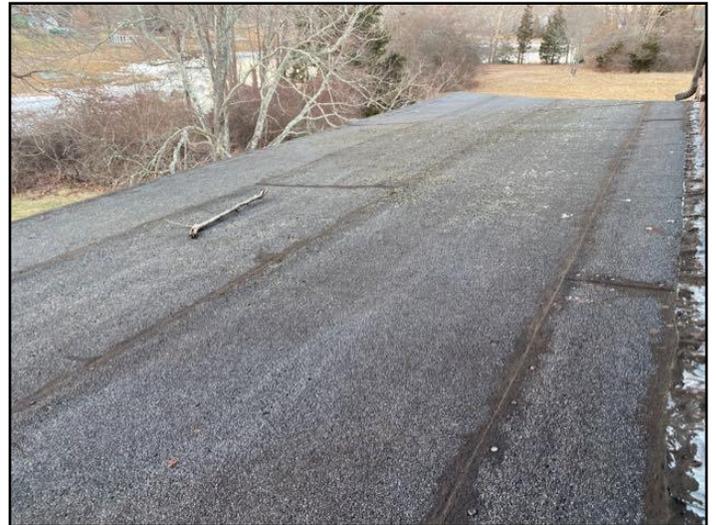
Roll roofing above left porch

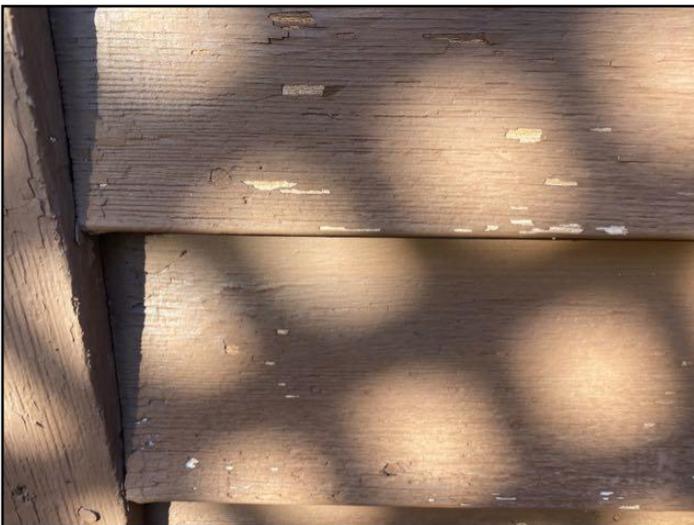
Much of the exterior paint films are thinning. Areas of chipping and flaking paint are readily visible on nearly every elevation of the exterior. While not an immediate concern the exterior will need to be painted by a qualified contractor in the future.

Detail of thinning paint films

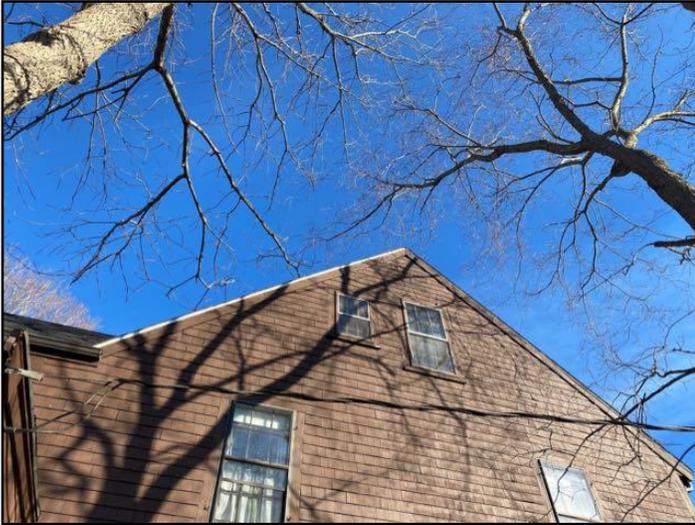
Tree limbs overhanging roof line

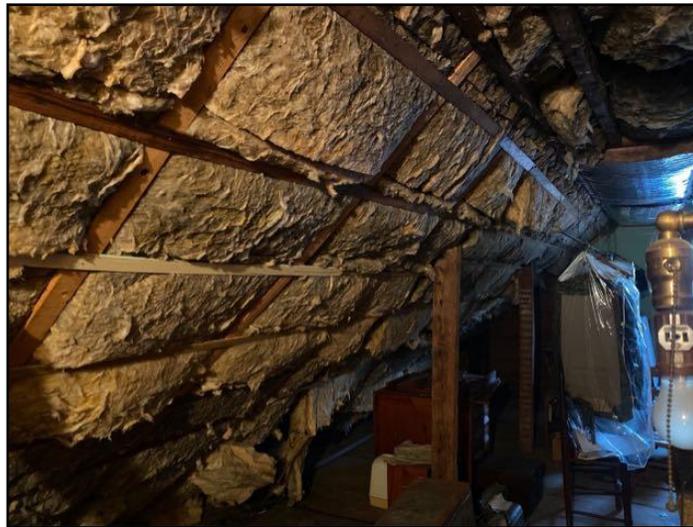
Batted insulation has been installed between the roof rafters throughout the attic. This application concealed the framing, sheathing and ventilation of the attic space from visual inspection.

Installed insulation obstructed view framing

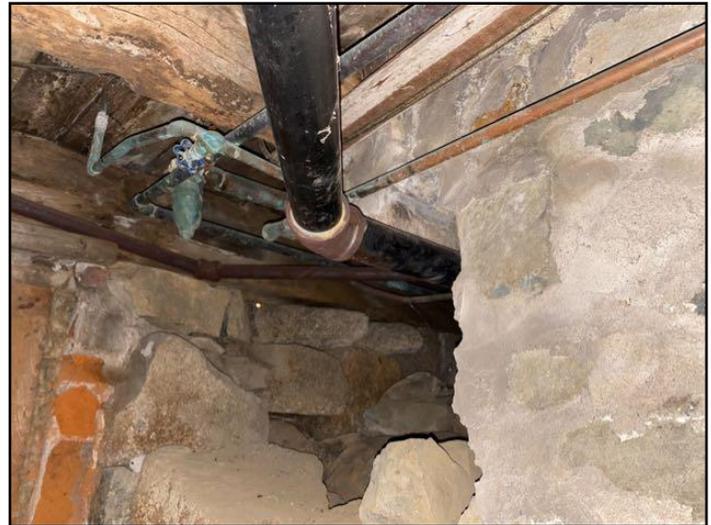
Example of crawlspace opening

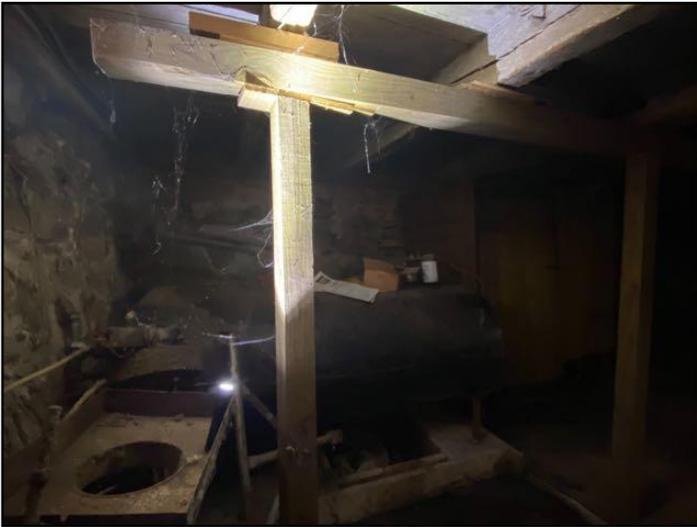
17. Condition: • Poorly secured at top or bottom

A secondary wooden post-and-beam support has been installed, running front-to-back, in the cellar hole. This installation does not reflect proper practices. The posts are not properly secured to the beam, nor are they secured properly to the floor. In fact, the front post is loose to the touch. Recommend you consult with a qualified contractor to have this installation improved.

Implication(s): Weakened structure | Chance of structural movement

Post and beam not secure

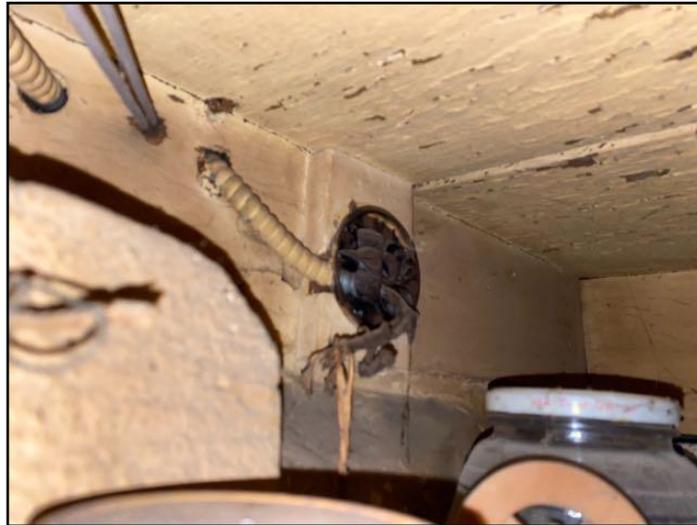
24. Condition: • Exposed on walls or ceilings

There is a cut and abandoned wire, carrying live current, in the small closet to the right of the fireplace opening in the first floor, left side room. This fire hazard needs to be properly terminated or removed by a licensed electrician.

Implication(s): Electric shock

Exposed wires in closet

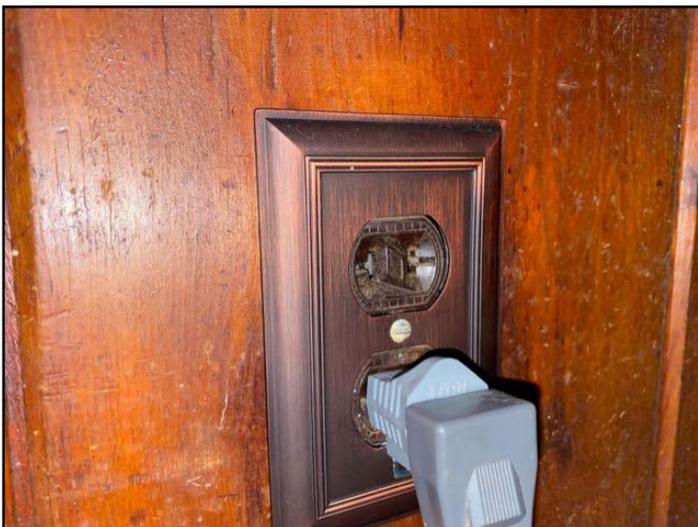
26. Condition: • GFCI/GFI needed (Ground Fault Circuit Interrupter)

Proper GFCI protection is missing in the home. These outlets should be installed in any areas where there is an increased likelihood of exposure to water: bathrooms, garages, exterior outlets, laundry areas, and kitchens for examples. Recommend you discuss with a licensed electrician and make necessary improvements. (Note: this improvement would be preceded by the installation of fully grounded wiring to these outlets.)

GFCI/GFI needed

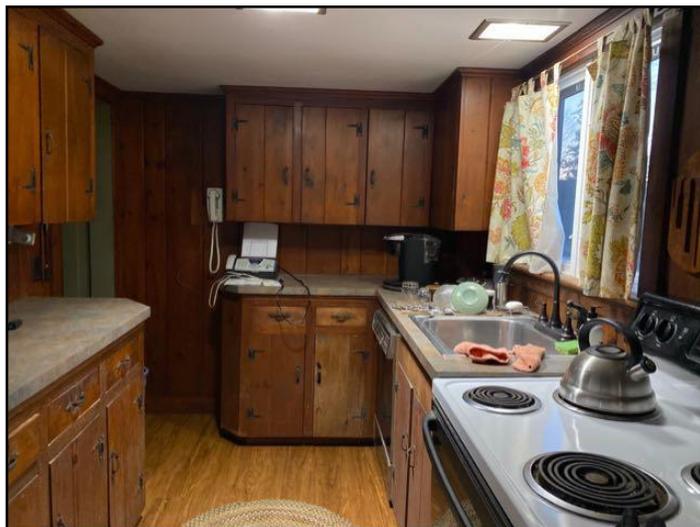
GFCI/GFI needed

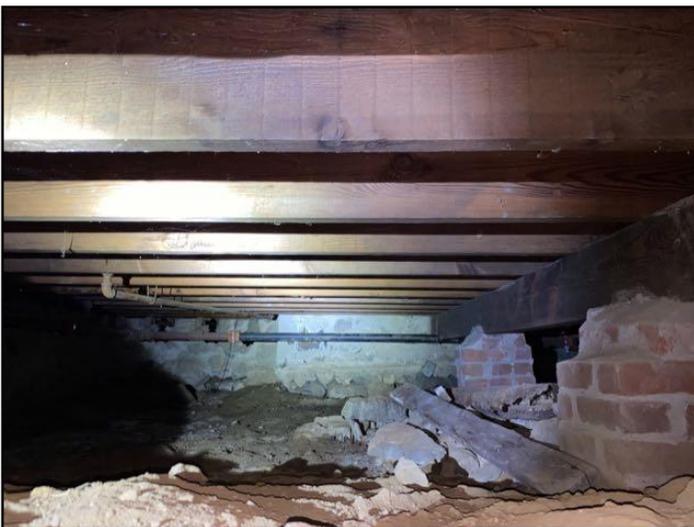
Implication(s): Increased heating costs | Reduced comfort

Too little insulation

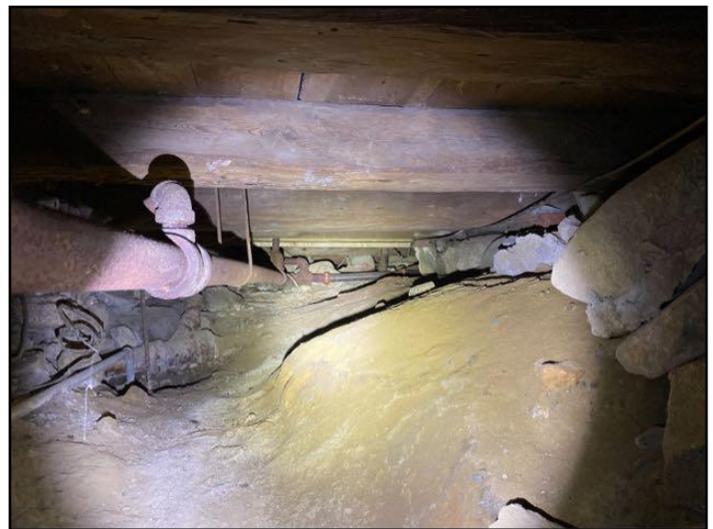
No vapor barrier

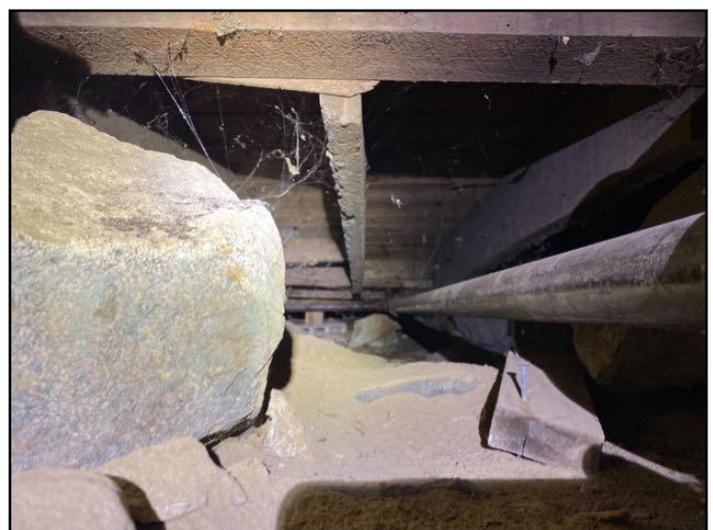
No vapor barrier

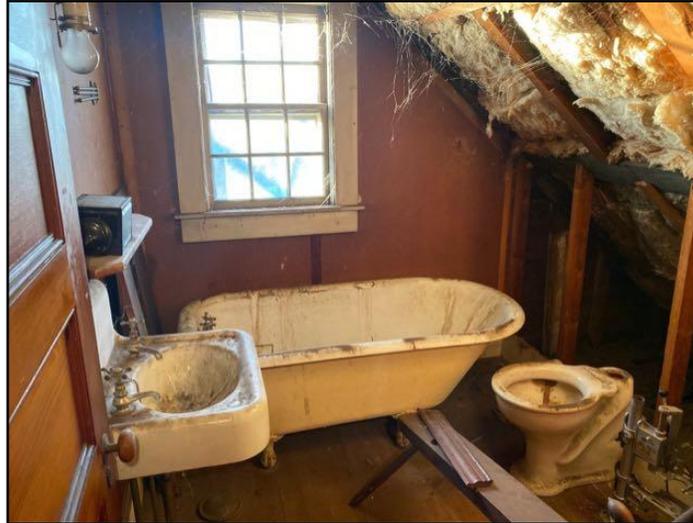
The attic level bathroom has been out of service for many years. None of these fixtures were evaluated.

3rd floor bathroom not active

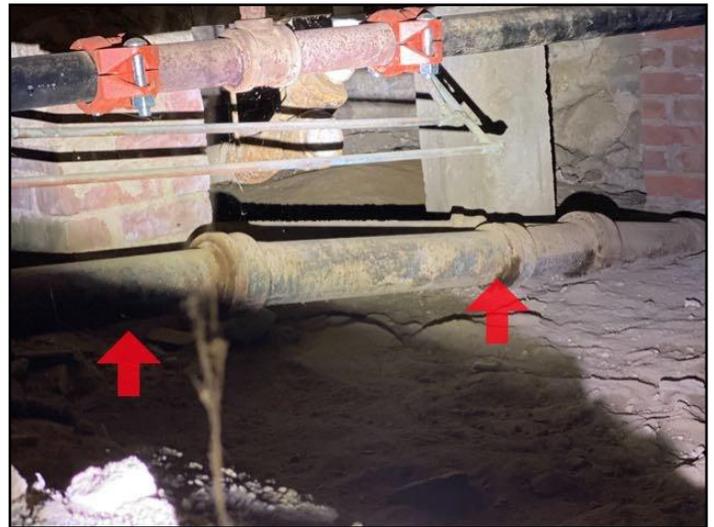
Implication(s): Sewage entering the building

Aging cast iron drain lines
